**Desert View Power**  
Economizer Discovery Work – 2020 Fall Outage  
Update: November 18, 2020

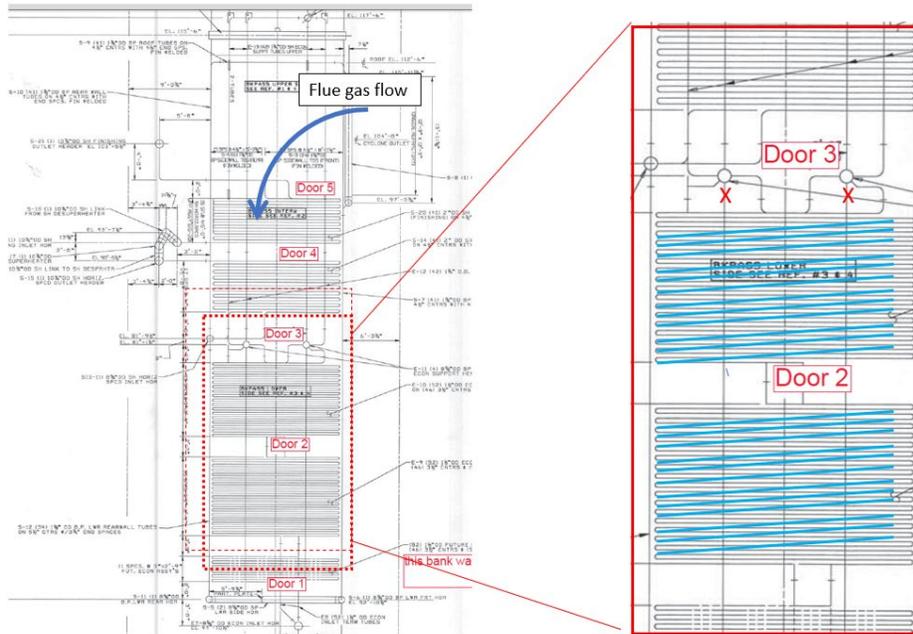
Side-view of backpass

Northern end of tubes have fallen, ranging from a few inches to 4 feet.  
 Southern section appears to only have moved inches.  
 Lower economizer is supported by upper, so both have dropped.

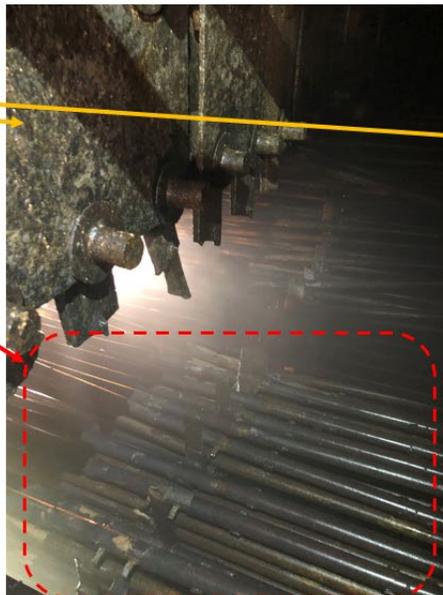
Top of upper economizer looking NW. Note broken straps in foreground. Tubes fell as much as 4 ft in this section. 24 pendants of the 51 fell.

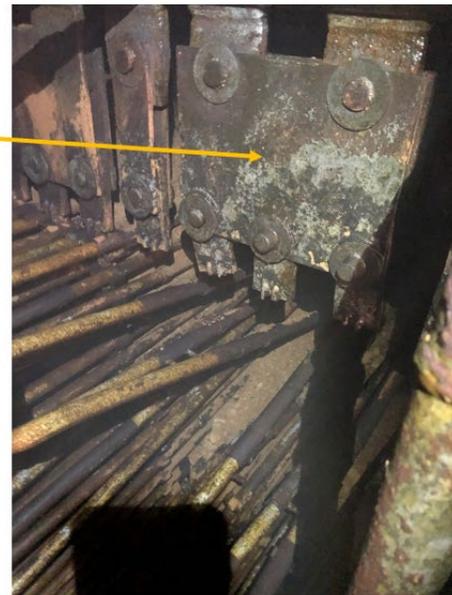
Top of upper economizer looking SE. Broken straps here too, most only fell inches.

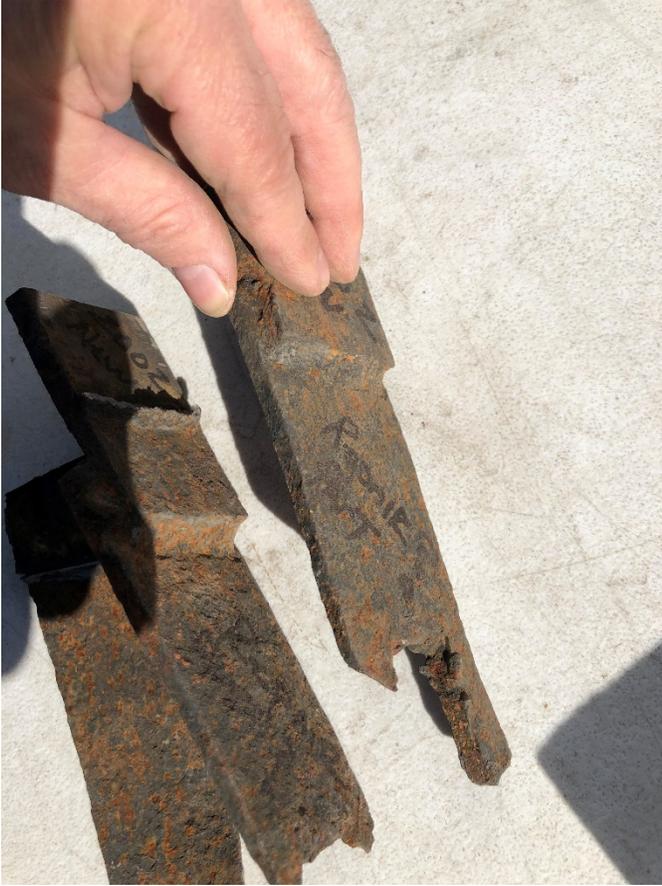
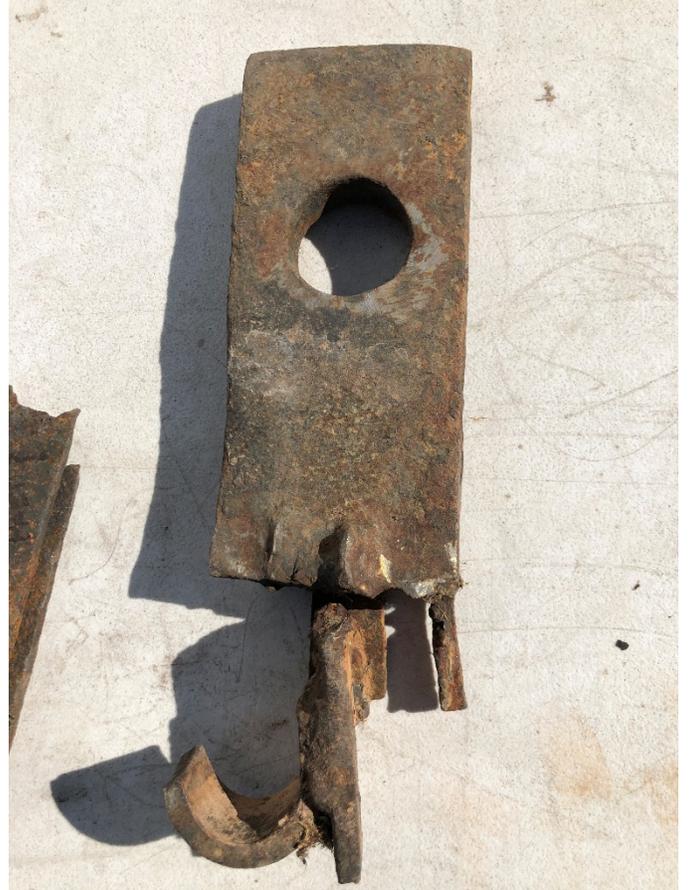
- **Erosion:** Hanger plates and straps are eroded in some sections. These are the load-bearing members that support the economizer pendants.
- **Improper prior repairs:** Prior repairs on hanger straps ("J-hooks") caused all weight to hang from a single point vs. original design that distributed the weight more.

Top econ. Has "J hook"-style tube hangers. Top of J-hook welds to plate that is welded to bottom of header. The weld and/or plate failed.

Eroded hanger strap components that failed
